# Property Condition Assessment

Single-tenant distribution warehouse, 42,000 sq ft  
4200 Example Commerce Way, Pompano Beach, FL (fictional)

**Prepared by**  
Richard Carfagna, Asset  
Inspection Group

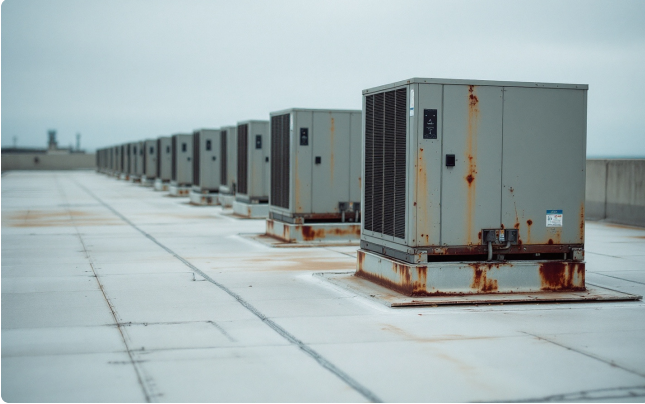
| System | Condition | Summary | Est. remaining life |
|---|---|---|---|
| HVAC | Poor | Six rooftop package units. Four are original (2004) with corroded coils and one failed compressor. Two replaced in 2019. | 4 units: 0 yrs |

**Photo 14, ref M-1.** Rooftop units 1 through 4, original to building. Cabinet corrosion at base rails and coil sections. View north.

| Ref | Item | Quantity and basis | Cost |
|---|---|---|---|
| M-1 | Replace four 7.5-ton rooftop package units at end of service life, including curb adapters, crane, disconnects and startup | 4 units at \$14,200 | \$56,800 |

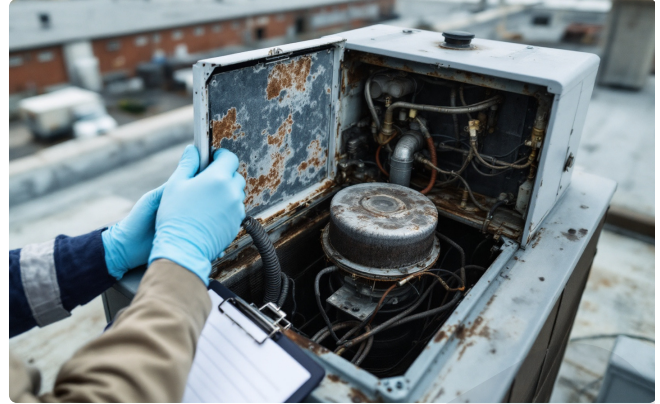
**Photo 17, ref M-1.** Unit 3 service panel open. Condenser coil fins deteriorated, compressor failed on test.

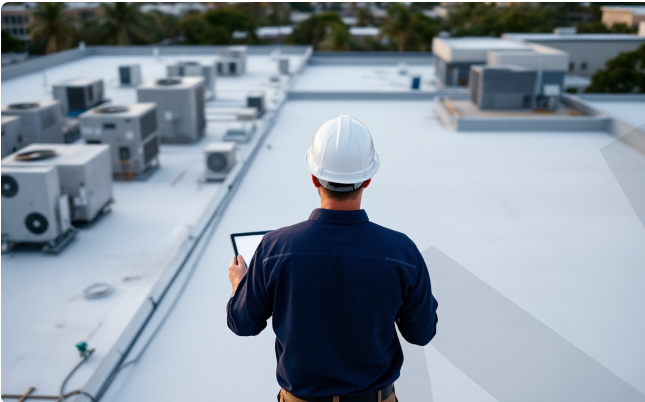
| System | Condition | Summary | Est. remaining life |
|---|---|---|---|
| Roofing | Fair | TPO membrane, 11 years old. Two areas of ponding near drain line. Seams intact. Three prior patches noted. | 6 to 8 yrs |

**Photo 22, ref R-1.** General roof view, TPO membrane. Ponding staining visible along west drain line.

| Ref | Item | Quantity and basis | Cost |
|---|---|---|---|
| R-1 | Correct ponding at roof drain line: add tapered insulation crickets at two locations, clear drains | 2 locations at \$1,050 | \$2,100 |

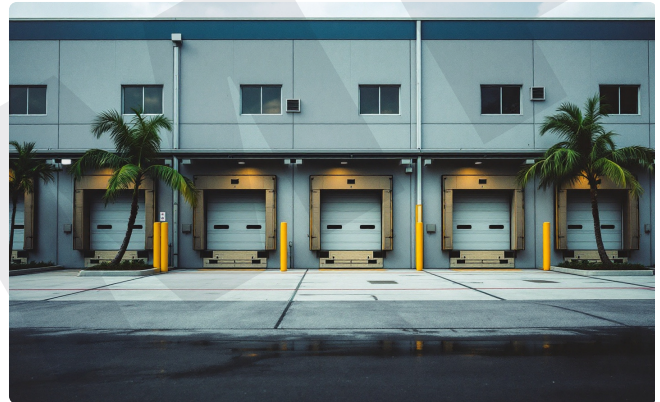
**Photo 3.** East elevation and dock positions. Tilt-up panels plumb, joints aligned.
